TASSI RANCH, TASSI SPRINGS  
Grand Canyon-Parashant National Monument  
Littlefield vicinity  
Mohave County  
Arizona

HALS AZ-2  
*HALS AZ-2*

### TASSI RANCH AND SPRINGS

HALS No. AZ-2

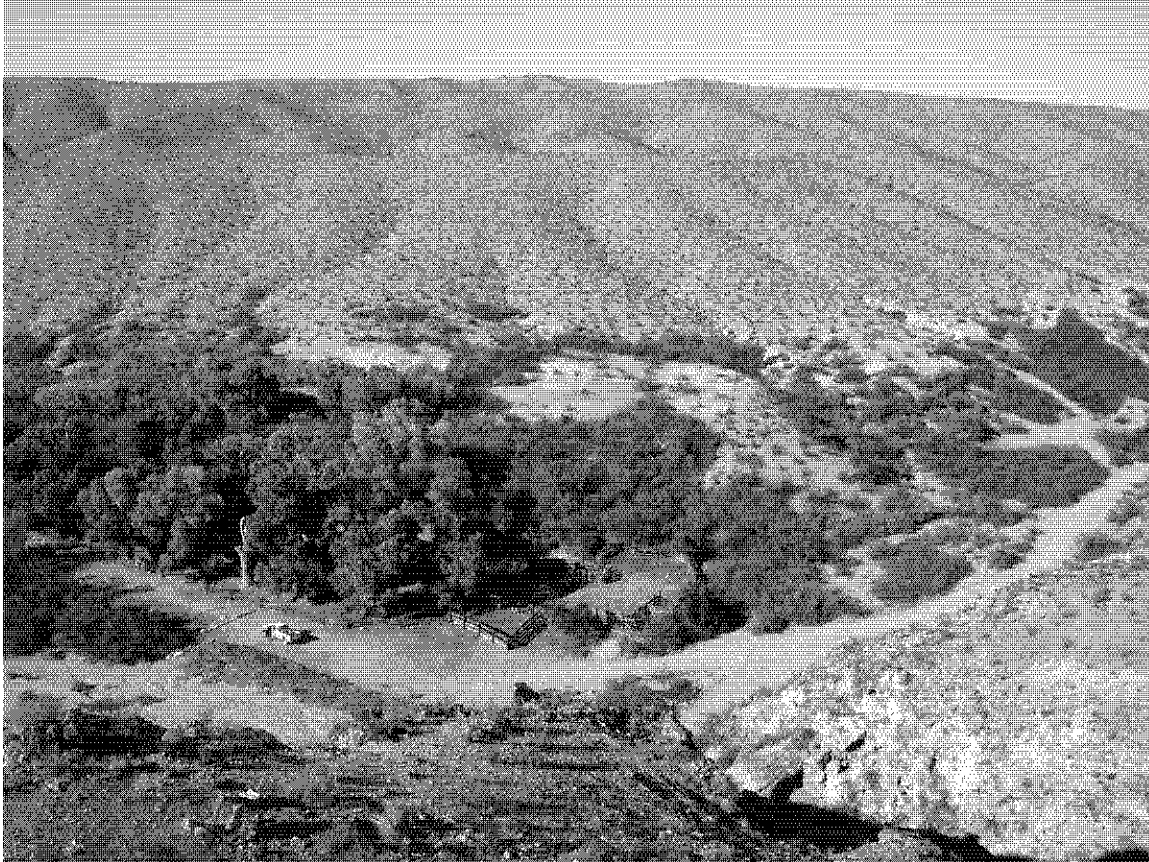
Fig. 1. The core area of Tassi Ranch, looking northwest from the top of the adjoining range. Lake Mead National Recreation Area Approved Road 152A enters from the right and passes the corrals near the lower middle of the photograph. The ranch house and barn are hidden amid the cottonwood trees to the left of the corrals. The largely barren, non-irrigated pasture above the ranch house and its enclosing fence are visible in the center of the image. Photograph by Alexander Matsov, November 2009.

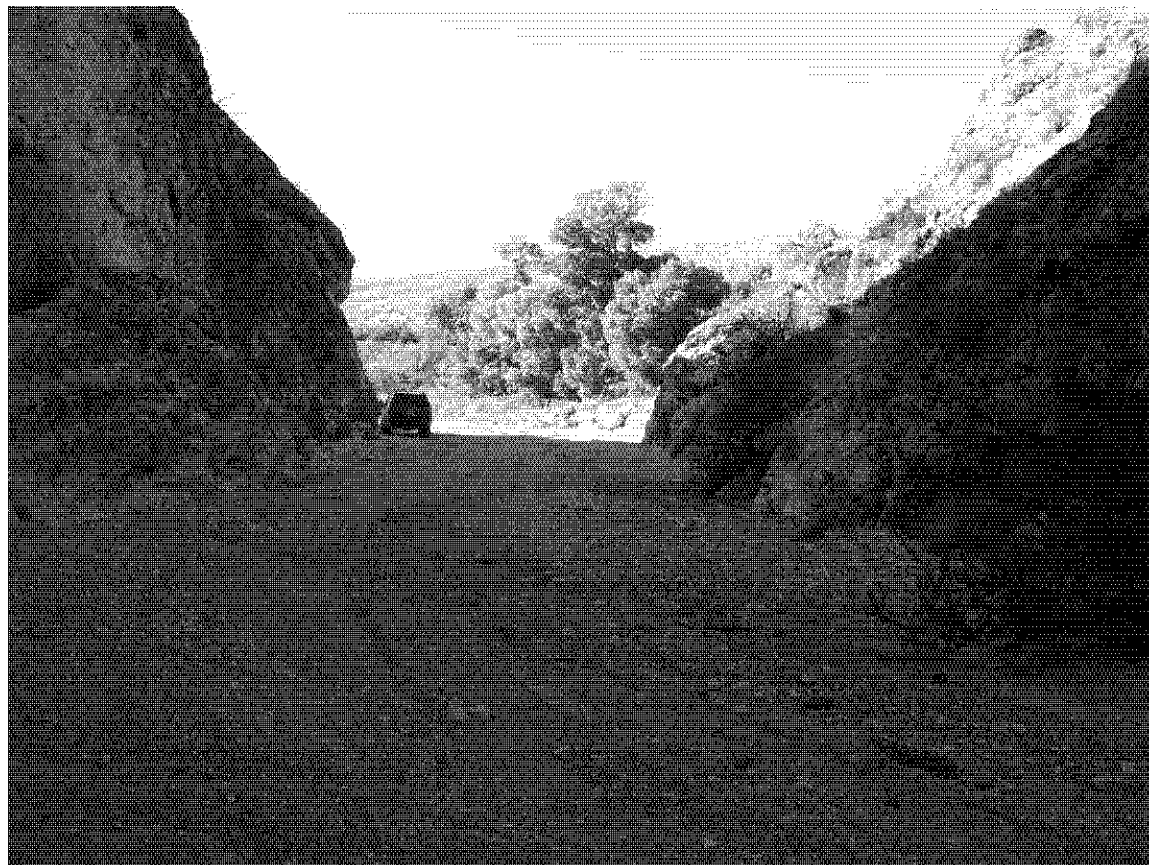
Fig. 2. The narrow walls of this pass, called the Box, tend to channel seasonal flood waters toward the ranch core. Flood damage in 2000 led the National Park Service to install the boulders visible on the far edge of Pigeon Wash as an erosion deterrent. Photograph by Christopher Stevens, November 2009.

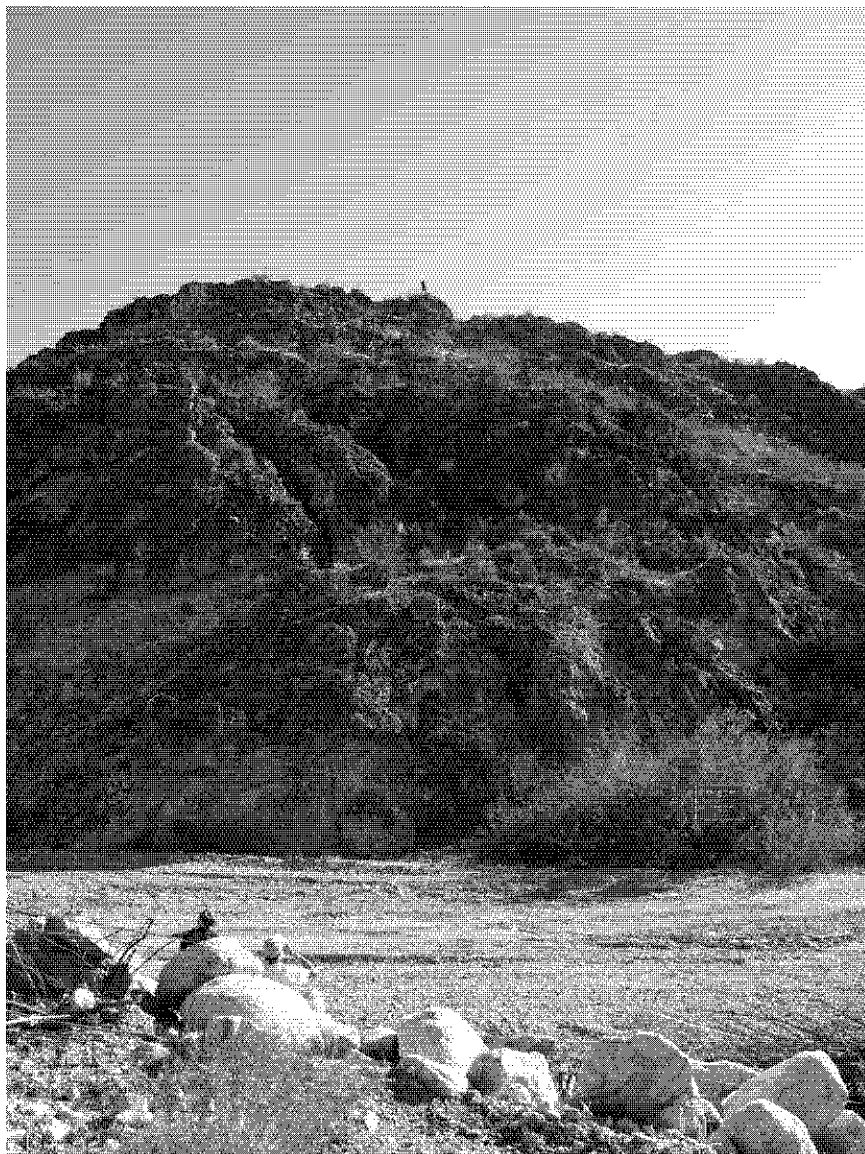
Fig. 3. Erosion-preventing boulders, the bed of Pigeon Wash, and the rock formation opposite the ranch core. Photograph by Christopher Stevens, November 2009.

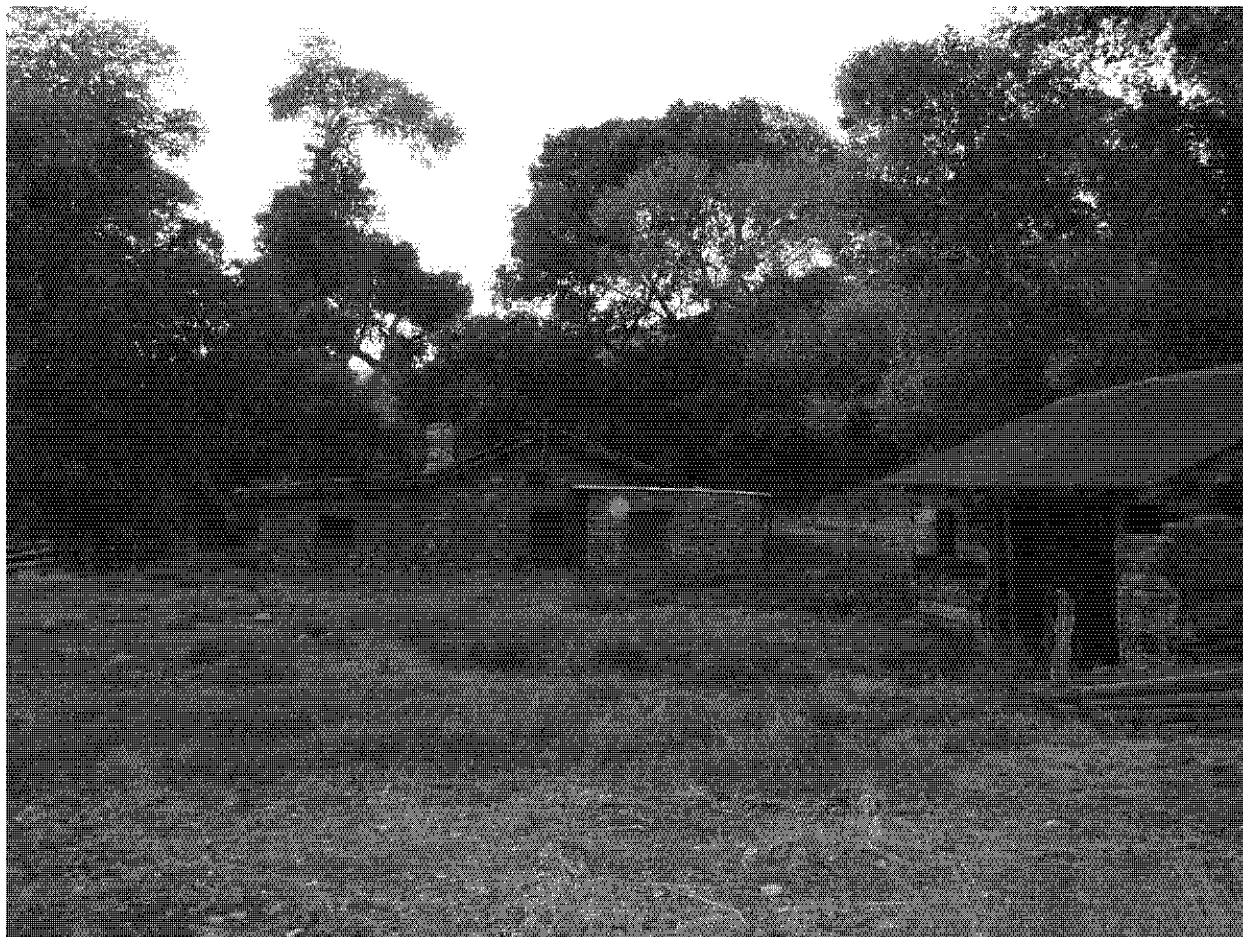
Fig. 4. The ranch house and barn. Photograph by Christopher Stevens, November 2009.

*Barn.* A small barn about 24' x 17' stands 31' east of the ranch house adjacent to the northwest corner of the corrals. It is built of salvaged railroad ties, stacked with notched and lapped ends in the manner of a log cabin. It rests on a dry fieldstone foundation and has a pitched wood frame roof covered by corrugated sheet-iron panels. The building contains two spaces, a large outer room (about 14' x 15') open to the yard along its south wall with a window facing east, and a small inner room (about 8' x 15') with south- and west-facing windows that opens off the outer room. The barn has dirt floors. A wood and wire coop, now in ruins, is attached to the barn's northeast corner. Photographic evidence reveals the barn was built before 1947.

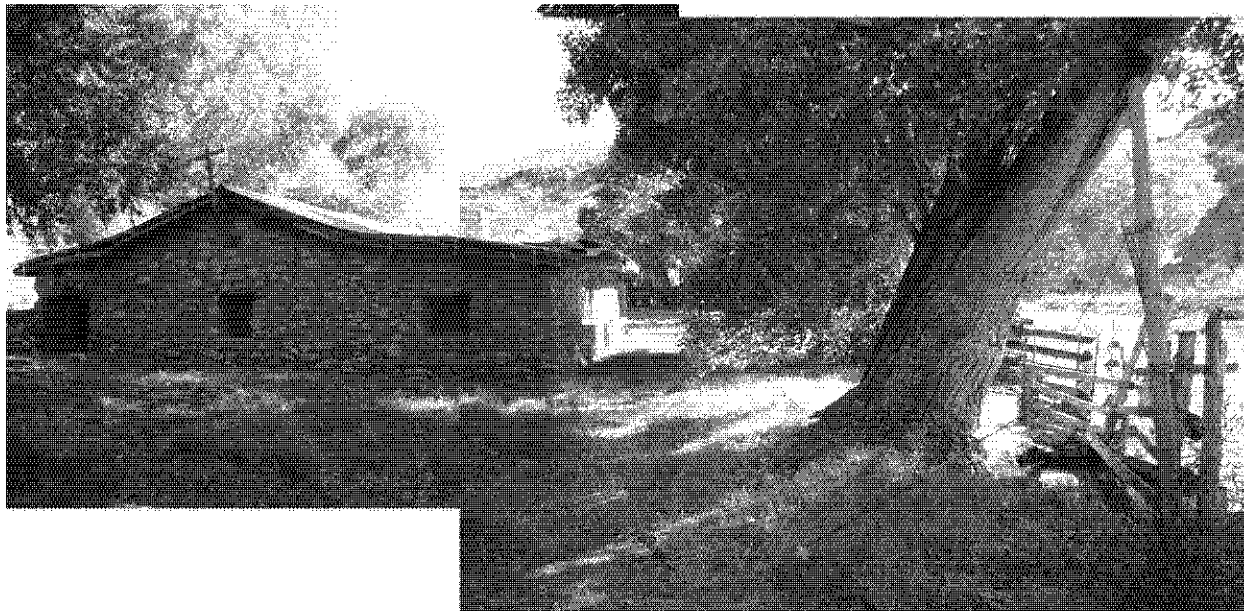
Fig. 5. Composite view of the ranch house, the row of cottonwood trees, and the worm fence installed by the National Park Service in 1994. The metal stock tank sits on the ground under the fence at right. Photographs by Alexander Matsov, November, 2009.

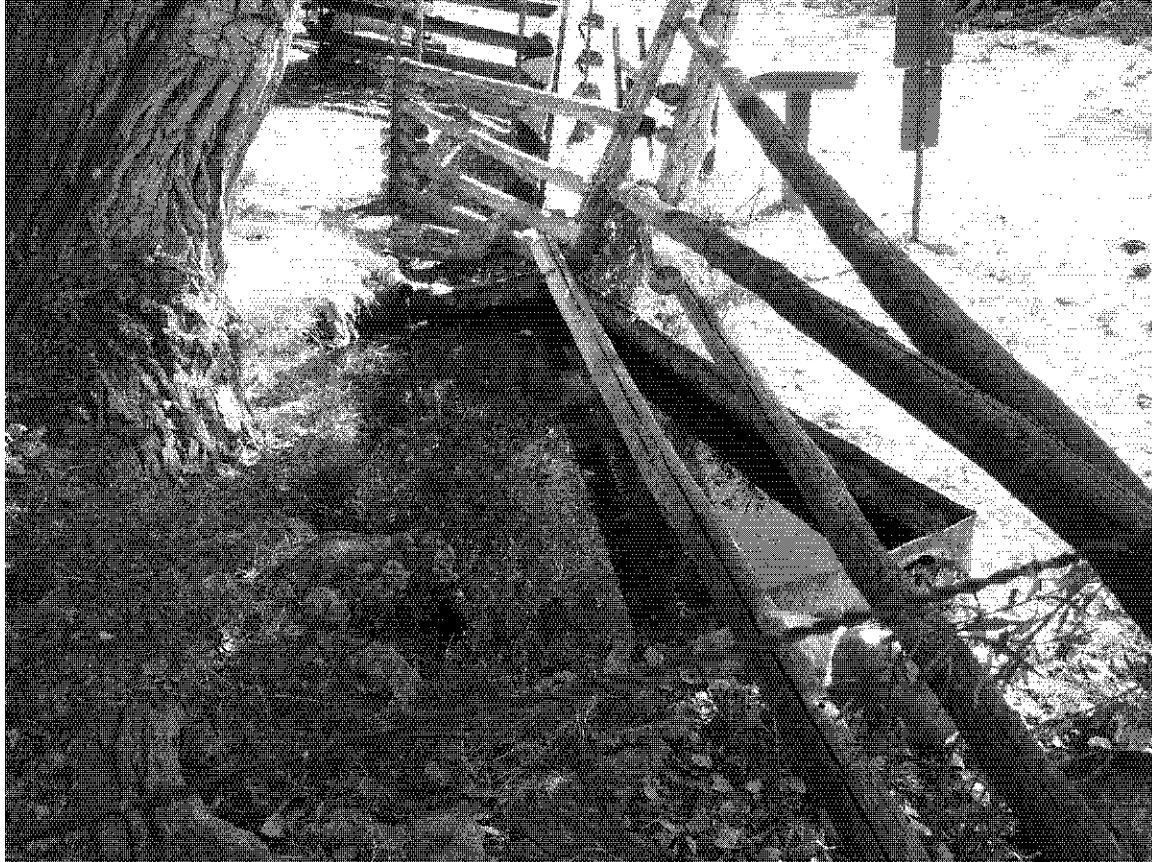
Fig. 6. The metal stock tank. Water from spring heads above the ranch house is brought to the tank by a partially buried hose. This hose was once longer and was used to fill a tanker truck used by the Whitmores to haul water to stock-watering tanks located throughout their grazing allotments. Formerly, the overflow from this tank flowed downhill along Pigeon Wash; now, a hole in the tank allows the water to seep directly into the surrounding ground, and the area has become a habitat for relict leopard frogs. Photograph by Christopher Stevens, November 2009.

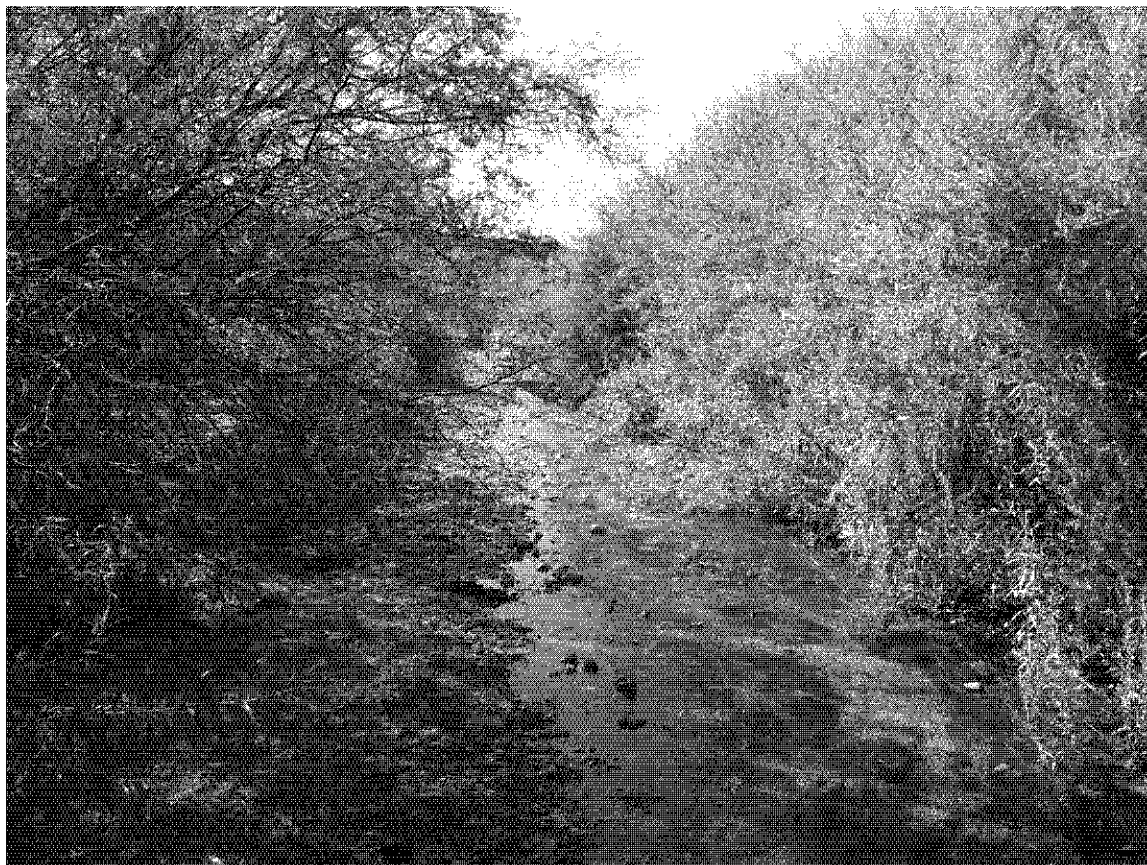
Fig. 7. Spring water flowing southwest from the ranch core along part of the bed of Pigeon Wash. This view demonstrates the extent to which the presence of water encourages dense plant growth around Tassi Springs. Photograph by Christopher Stevens, November, 2009.

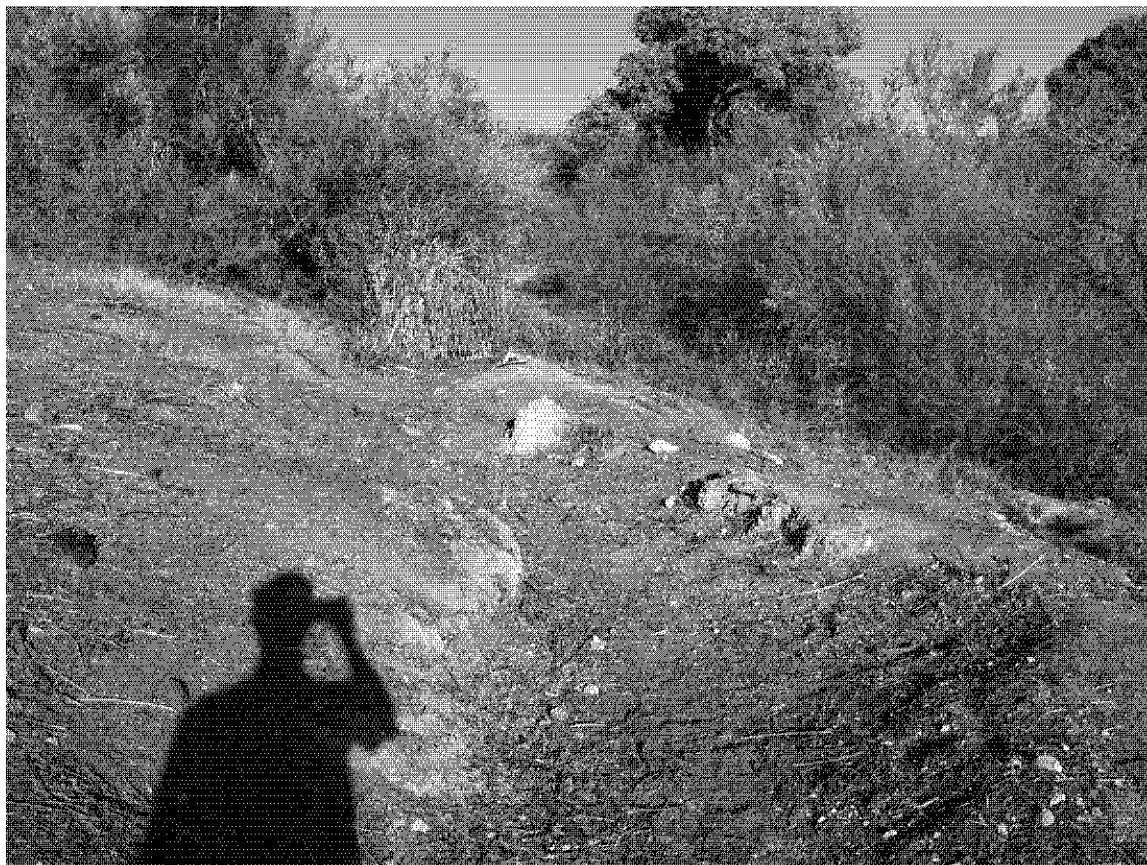
Fig. 8. The main irrigation ditch, looking east toward the ranch core. The clear demarcation between plant growth and desert shows the effects of a breach in the ditch. Photograph by Christopher Stevens, November 2009.

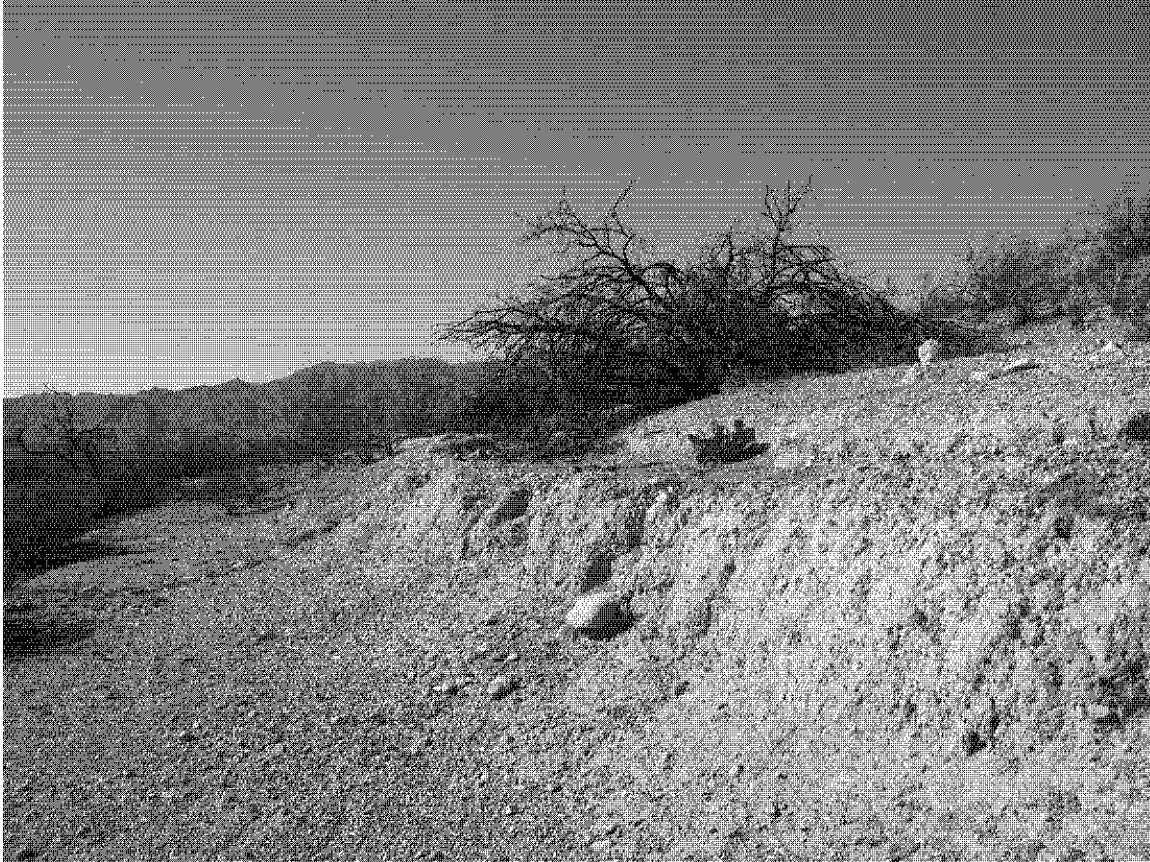
Fig. 9. The access road from Pigeon Wash to the west holding pond. The main irrigation ditch runs along the top of the rise above the road, where the prickly pear cactus is seen growing. Photograph by Christopher Stevens, November 2009.

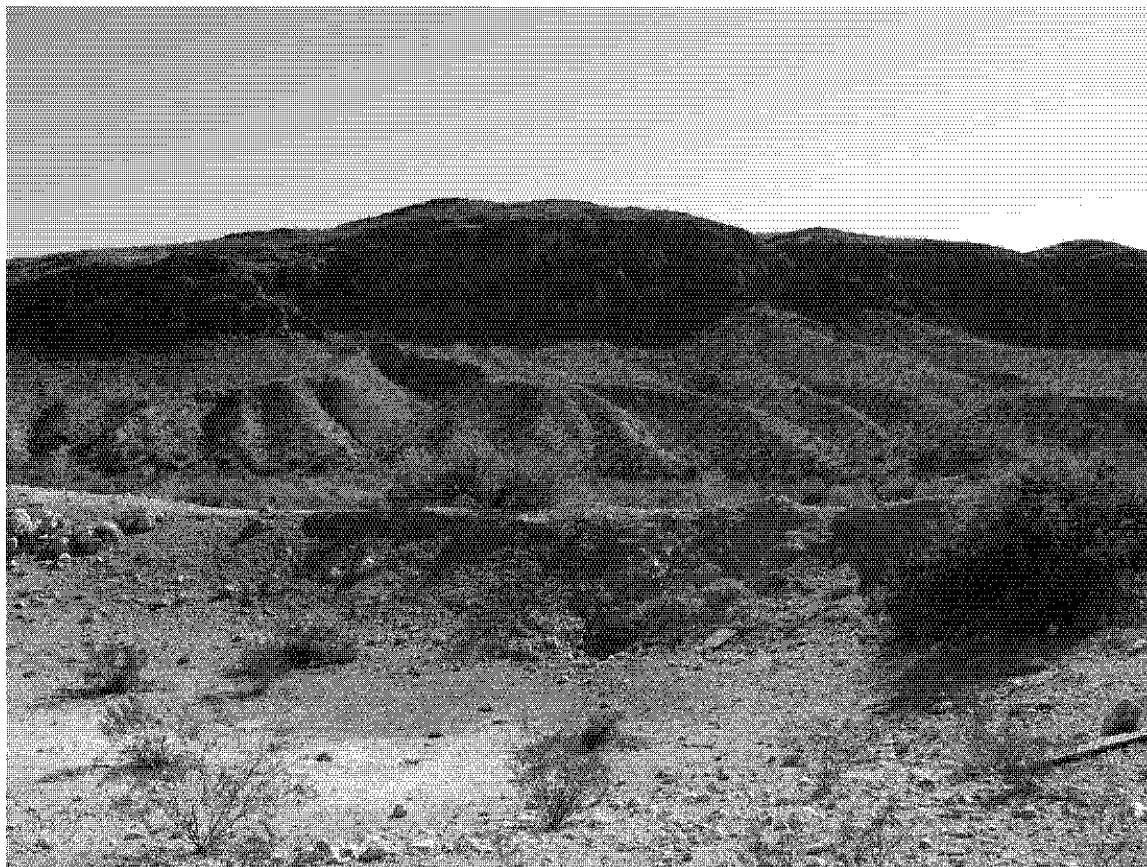
Fig. 10. The basin of the west holding pond, looking toward the mountains south of the ranch. The indentation along the lower edge of the berm in the center of the photo is one of the pond's two drains. Photograph by Christopher Stevens, November 2009.

<sup>21</sup> Field measurements made by the HAER team in 2009 indicate the west holding pond has a capacity of about one acre-foot, which is twice the size authorized by Yates’s water certificate. Is it unknown if Yates

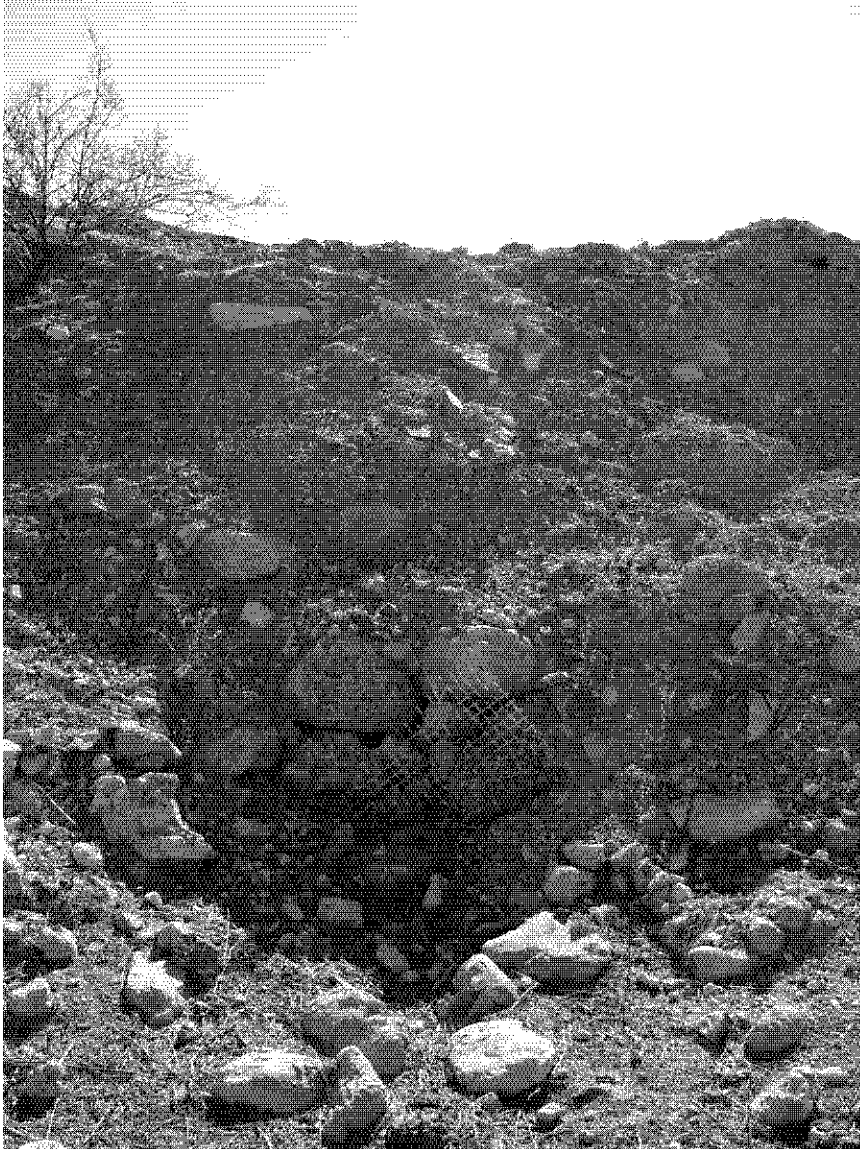
Fig. 11. The south drain in the west holding pond. Photograph by Christopher Stevens, November 2009.

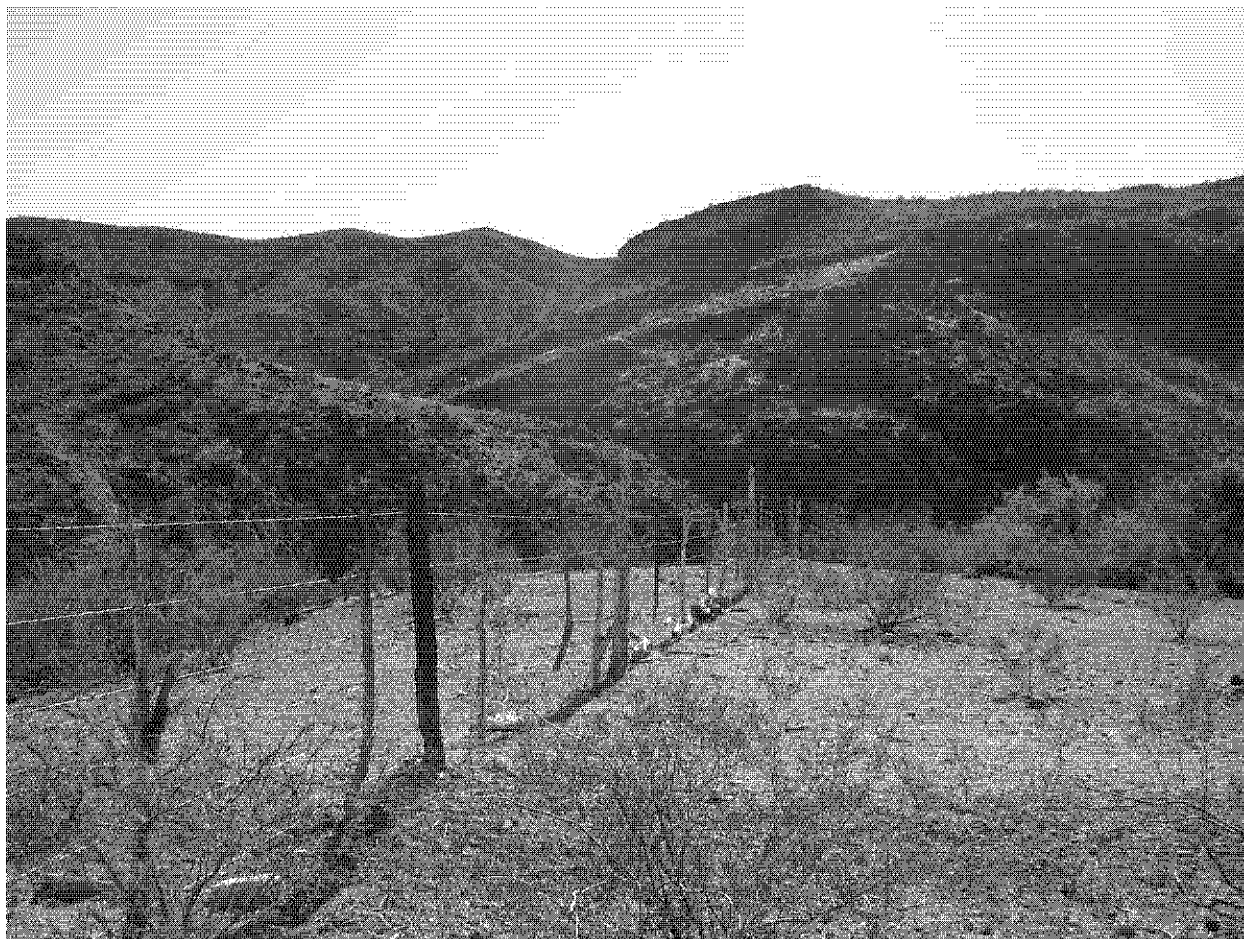
Fig. 12. The restored fence enclosing the pasture above the ranch core, showing the rough wood posts fashioned from native tree trunks and limbs that historically supported most of the barbed-wire fencing at the ranch. Photograph by Alexander Matsov, November 2009.

the ranch into eastern and western zones. The northern fence line runs for about 2,240' along the northern edge of the upslope pastures. The western fence line runs approximately 340', although a section 92' in length is missing. The southern fence line follows the north side of Pigeon Wash, a run of about 2,500'. Part of this line is obscured by dense vegetation, however, while large sections comprising about 770' are collapsed or missing, many from erosion into the wash. A section of wood worm fence installed by the NPS immediately south of the ranch house and barn in 1994 replaces a lost run of post-and-rail fence that once formed part of this fence line. The corrals form the southeastern corner of the ranch's fence system, connecting the southern line to the eastern line, which proceeds uphill for about 270' to the northeast corner of the ranch. The middle fence runs north to south about 220' and separates about 5 acres containing the ranch core from the about 21 acres of fields and pastures to the west.<sup>59</sup>

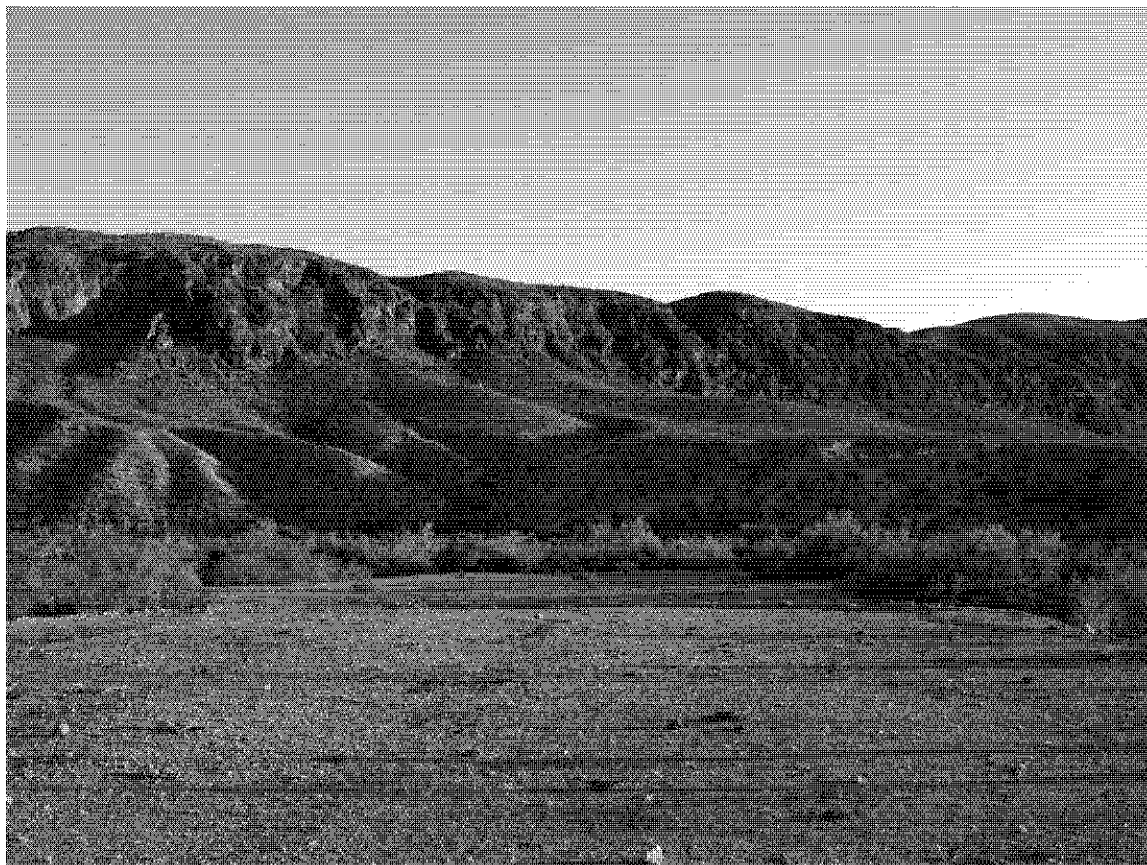
Fig. 13. The low table land at the western end of the ranch that was formerly irrigated for use as pasture. Lake Mead National Recreation Area Approved Road 148 rises out of Pigeon Wash on the far side of the valley, leading past the Whitmores' landing strip to Lake Mead, about three miles to the southwest. Photograph by Christopher Stevens, November 2009.
