TUMACÁCORI NATIONAL HISTORICAL PARK
Tumacacori National Historical Park
1891 East Frontage Road
Tumacacori
Santa Cruz County
Arizona

HALS AZ-12
HALS AZ-12

WRITTEN HISTORICAL AND DESCRIPTIVE DATA

HISTORIC AMERICAN LANDSCAPES SURVEY

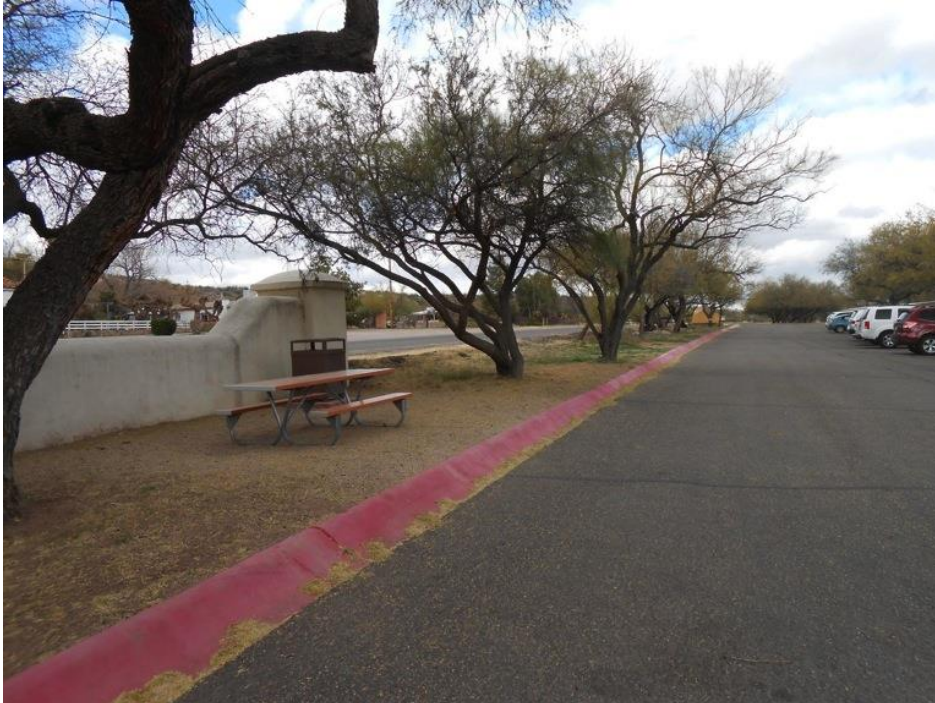
Figure 5: Remaining portion of original parking lot wall, table, and row of trees, looking west (Allison Dunn, February 2014).

Although highway safety renovations have impacted the original entrance to the parking area, the church remains invisible from the road and the parking. The parking lot has been transformed into a driving aisle with a single row of parking stalls along the interior wall and the front of the Visitor Center. The Visitor Center entrance continues to mark the visitor entrance. A section of the 1930s wall between the parking lot and the road still stands in a landscaped buffer strip containing picnic tables, benches, trash cans and a flag pole. This buffer serves as a barricade separating the road from the one-way access to the parking. The 1930s gate is no longer present. Sidewalks run the length of the park's west boundary wall, defining a circulation route from the parking stalls to the Visitor Center entrance. This sidewalk is constructed of several different types of red pavers, suggesting that it has been altered or repaired over time. Several mature mesquite trees and informational signage frame the entrance to the Visitor Center.

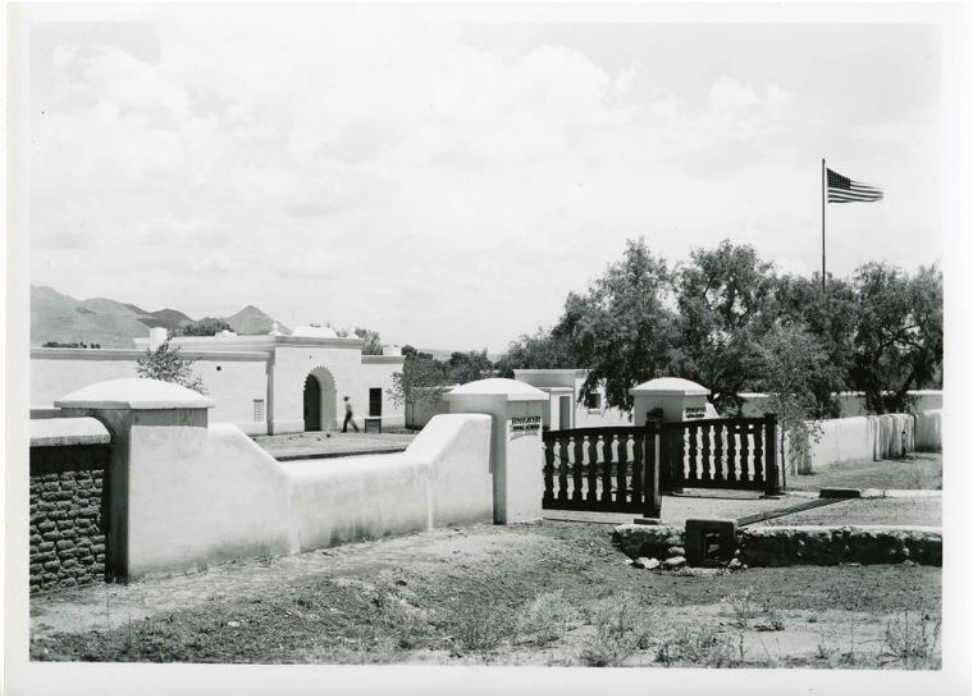
Figure 8: Original wall and gate to the Visitor Center, looking southeast (George A. Grant, date unknown, WACC).

Historic photographs suggest that Pinkley's goal was to provide a guided experience from the moment of a visitor's arrival. Walls blocked a view of the church ruins from the road, and a 90° turn was required to enter the parking court through a double gate, which could be closed when needed. Once in the parking court, a second wall separated the parking from the ruins, continuing to block the view. The decoratively-arched entrance to the Visitor Center draws immediate attention.

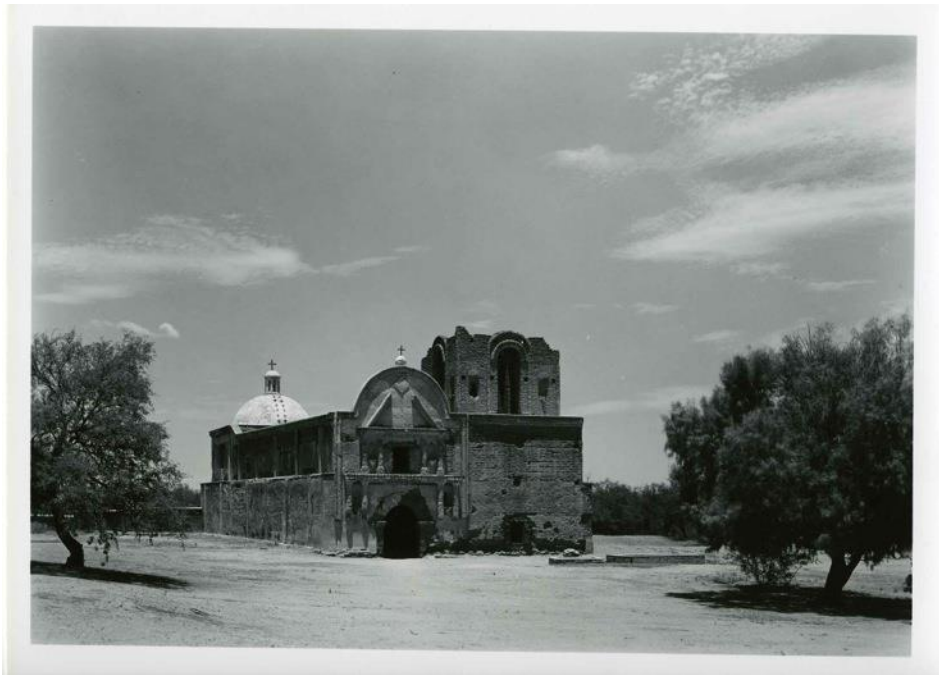
Figure 13: Looking toward the mission ruins from the view room with sidewalk pathways in foreground, looking north (Allison Dunn, February 2014).

The church and plaza are set in a characteristic desert landscape of sparse grass punctuated by mesquites. An earthen-colored concrete sidewalk winds northward from the Visitor Center to direct the approach to the church. The concrete sidewalk, which was installed in 2012, follows an earlier pathway. To the west is the lime-plastered adobe wall with a wedge-shaped adobe cap that separates the plaza from the parking lot. A row of randomly-spaced (possibly volunteer) mesquite trees run along the wall. Between the trees and the church to the east is a low, grass-covered mound that marks the foundations of deteriorated living quarters. To the east of the Visitor Center, there is a group of mature mesquite trees, two of which are noticeably larger than the others. An adobe wall similar to the west perimeter wall extends east but ends abruptly at an open area where traditional crafts such as tortilla-making are demonstrated.

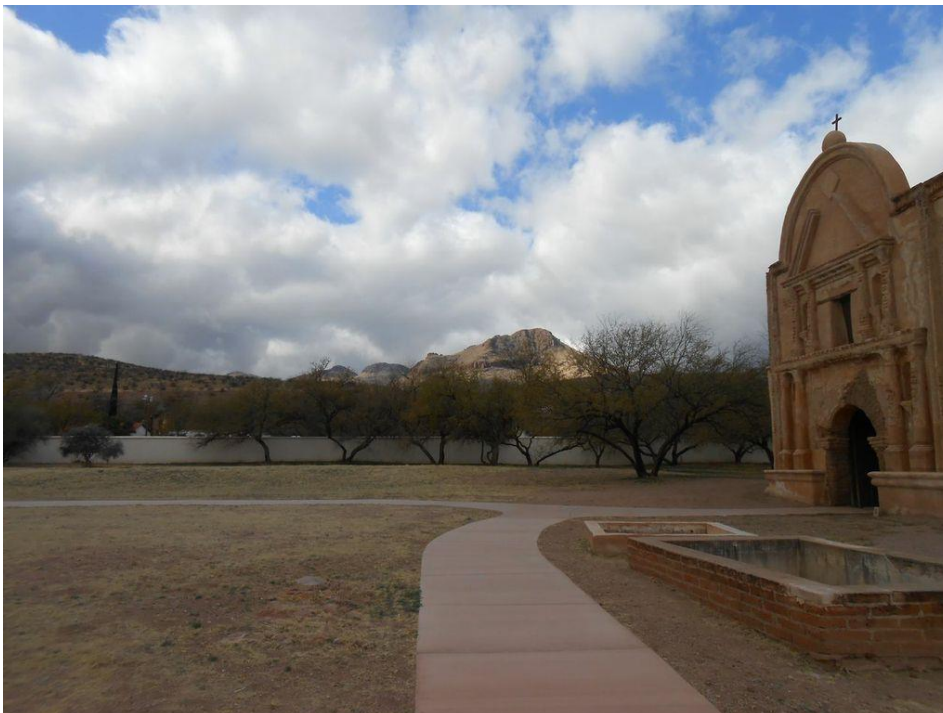
Figure 15: Cisterns and Convento with convento ruins and Santa Rita mountain view in background, looking north-east (Allison Dunn, February 2014).

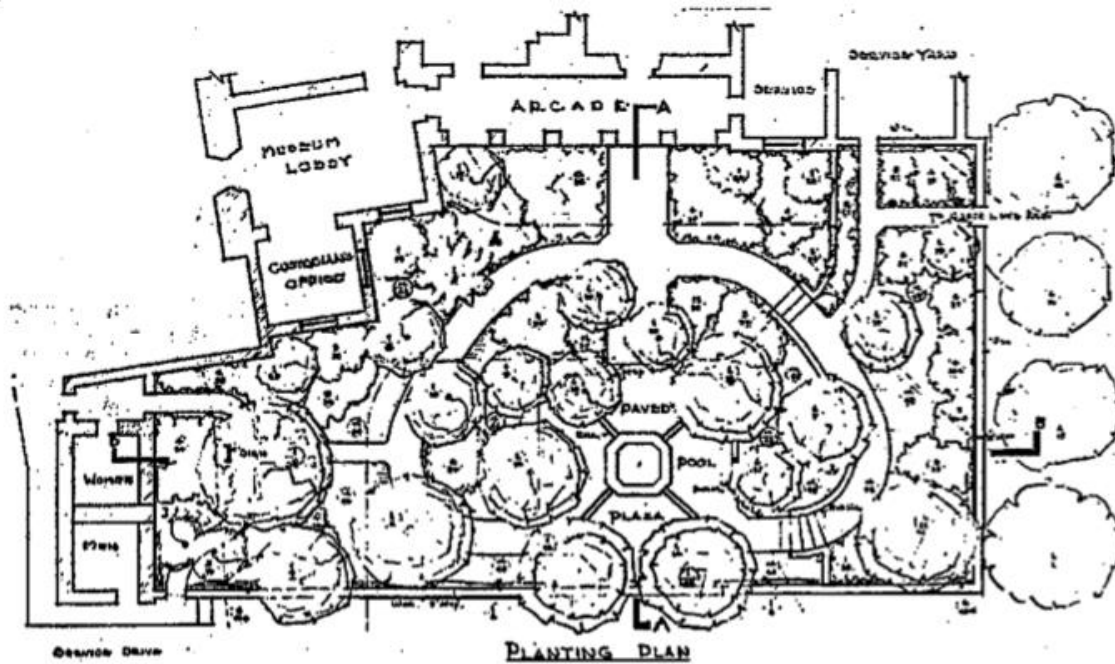
Figure 19: Proposed plan for garden (Colby, 1938: 13).

Plans for the garden included a central fountain to serve as a focal point and place of rest, a geometric layout that recalled the formal design of ‘paradise gardens’. Persian/Moorish gardens were typically enclosed, accessed by some sort of indoor/outdoor walkway, and included a four-cornered fountain to resemble an oasis in the desert. The style was brought to Spain with the Moorish conquest, and later traveled to Mexico with the Spaniards.²⁹ The combination of the geometric fountain and patio surrounded by an informal curved loop walk and the mix of native and European plants are telling details that explain the thought process behind the entire Visitor Center as an interpretive device. The revival style of drawing elements from various sources and combining them into a romantic whole is characteristic of the aesthetic and values of the time period.³⁰

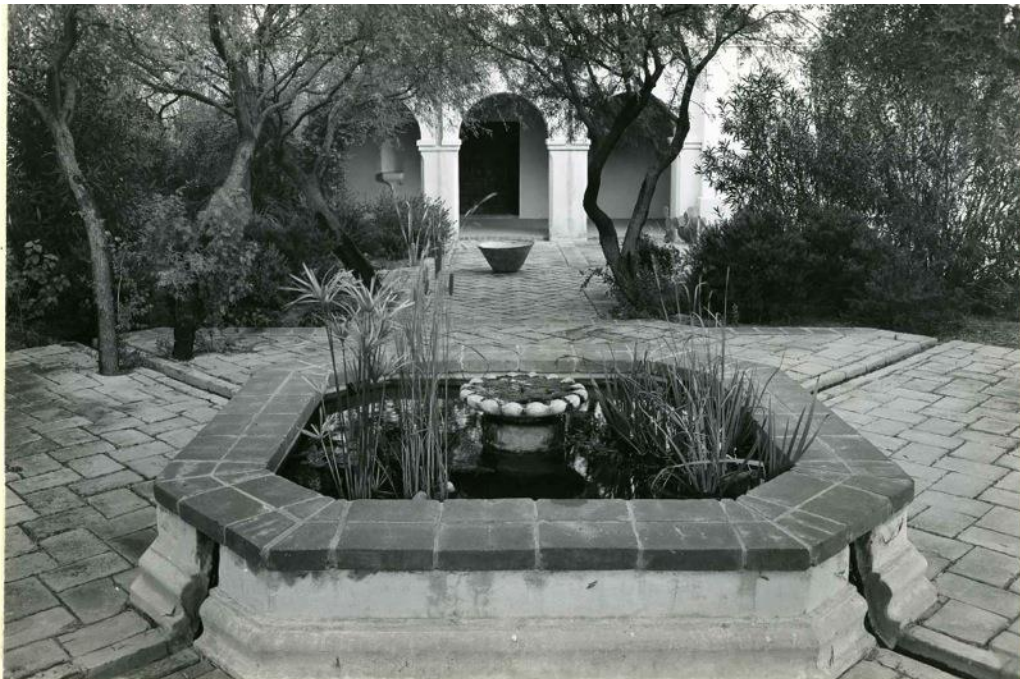
Figure 20: View of Visitor Center garden fountain built by CCC workers, looking north (Harry Reed, 1945).

Construction of the garden was begun in 1939 by engineer Howard Tovrea, landscape architect Charles Carter and sixteen CCC (Civilian Conservation Corps) men who built the fountain and benches, paved the brick walkways and planted trees. Together with Pinkley, Tumacácori park staff, and the design team from the Landscape Division, the Tucson Botanical Garden supervised the planting of the garden according to the planting plan.³¹ The general planting scheme of the garden has been maintained since its creation. The native plants area was added in 1949, and up until at least 1969 the fountain was referred to as the ‘pond’ and was stocked with native Santa Cruz River (and later, tropical) fish.³² A 1997 proposal prepared by the University of Arizona recommended the gradual removal of plant materials deemed inappropriate.³³

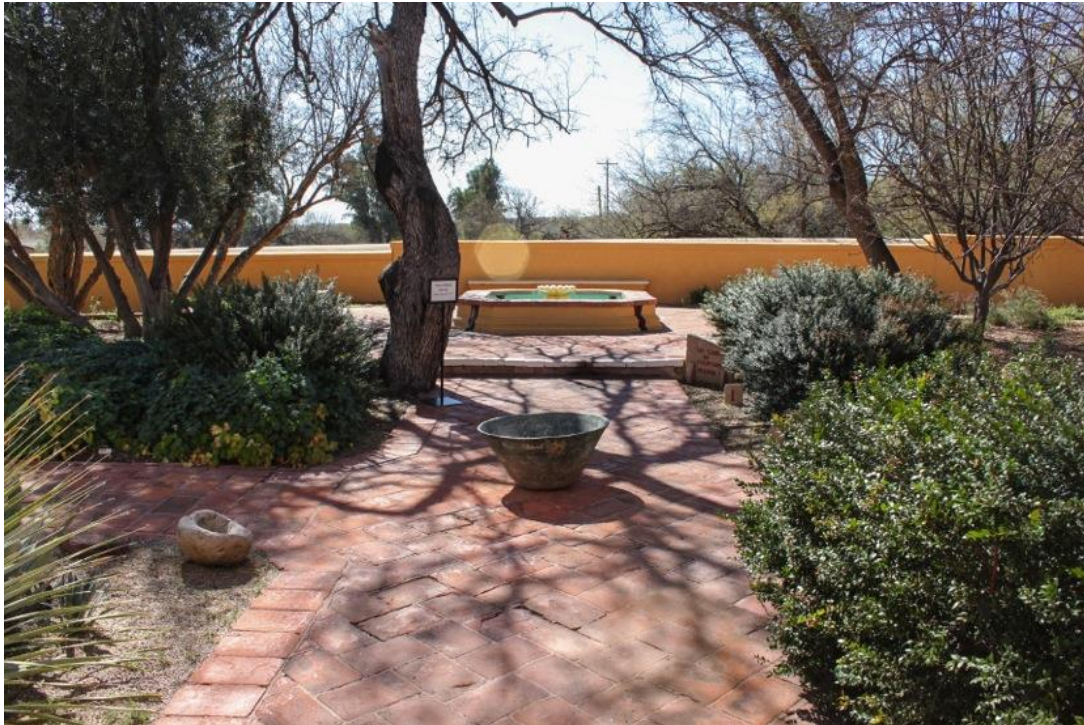
Figure 21: Visitor Center garden fountain with view of brick paths laid by CCC workers, facing south (Starr Herr-Cardillo, February 2014).

The visitor enters the garden through the Visitor Center. A brick path oriented north/south leads directly to the fountain and to the south wall beyond. Before reaching the fountain, the path splits to the east and west and continues in two curvilinear paved walkways that are reunited along the west wall south of the fountain. These pathways form two interior planters to the east and west of the fountain patio. To the west, the path leads to the comfort station. To the east, the path descends three steps before turning back to rejoin the entrance walkway at the fountain. The garden boundaries are set by the walls and covered walkway of the Visitor Center to the North, the comfort station to the West, and a stepped adobe wall to the South and East.

The central fountain features drainage channels at its four corners. These are intended to carry water to the adjacent vegetation beds. It appears that northeast corner has sunk over time, and it now receives more water than originally intended.

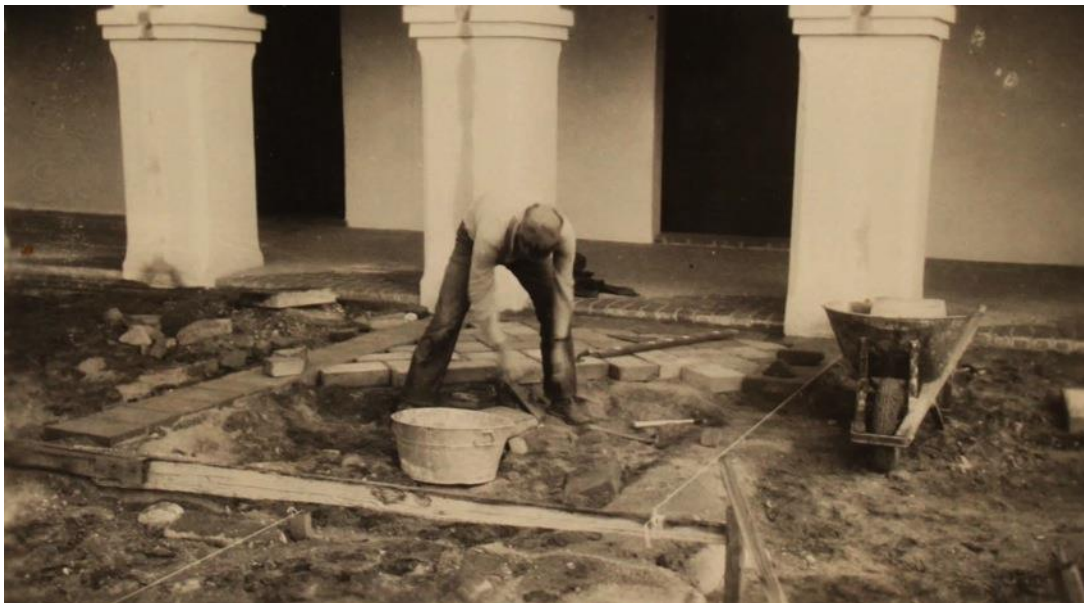
Figure 22: A CCC worker lays bricks for the garden walkways (Frank Pinkley, 1939, Tumacácori National Historical Park Library).

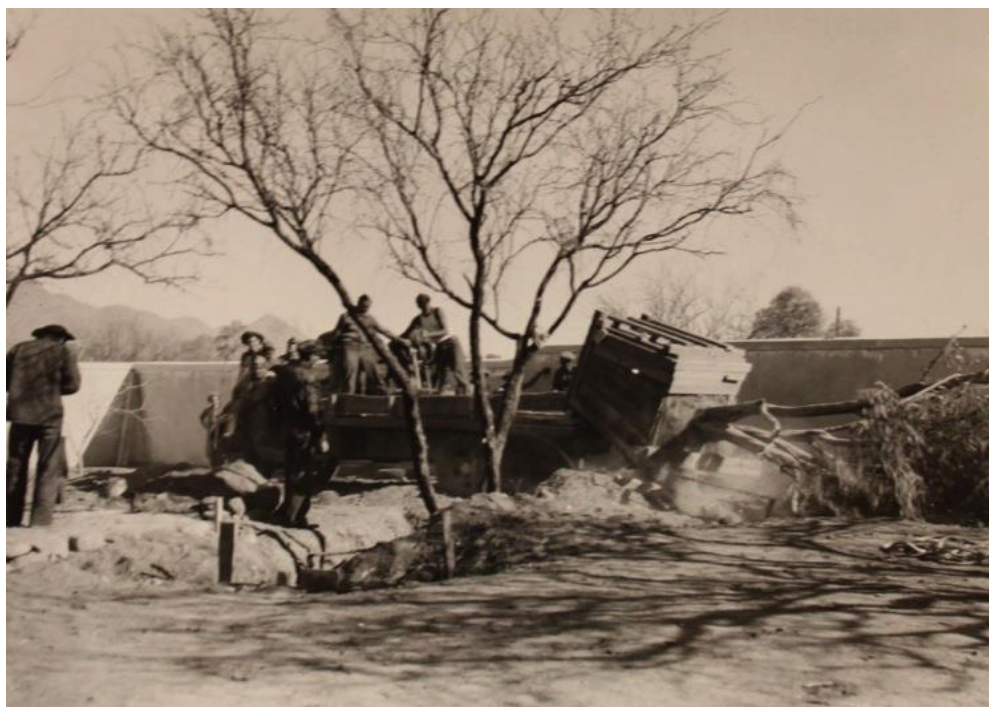
Figure 25: The CCC crew posing for a photo while planting trees in the Visitor Center garden. The tree on the left is a mesquite (Louis Caywood, April 1939, Tumacácori National Historical Park Library).

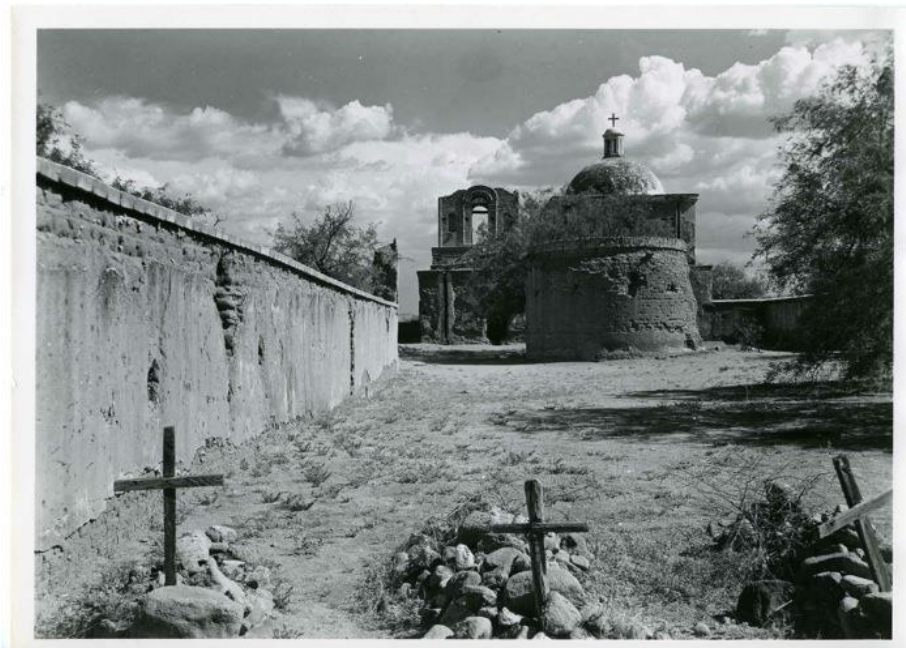
Figure 28: View looking south of burial grounds and mortuary chapel (Harry Reed, August 1945, WACC).

A cylindrical adobe mortuary chapel with a western entrance (aligned with the gate that now exits to the parking lot) stands near the southern end of the burial ground. It has no roof. It is surrounded by piles of cobble stones or rectangles of cobbles and by wooden or metal crosses to serve as grave markers. The grave of baby Juanita Alegria is prominent, featuring a white wooden cross, paper flower display, and cement slab. Several volunteer mesquite trees have grown up in the center of the burial ground and in the northeastern corner. The earthen ground surface appears to have been covered with decomposed granite at some point.

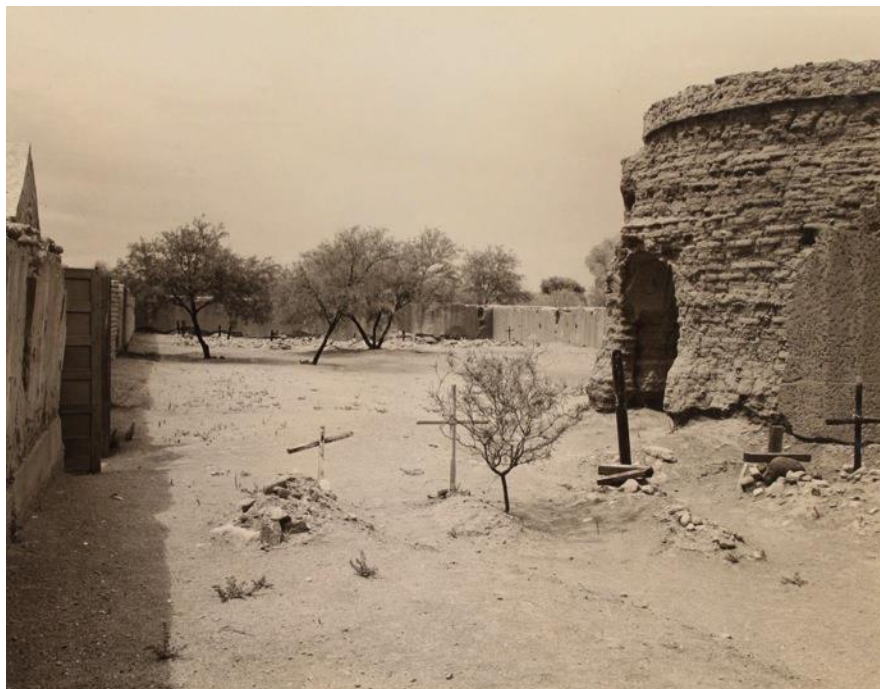
Figure 29: View of the mortuary with exposed adobe, facing north (George A. Grant, 1929, Tumacácori National Historical Park Library).

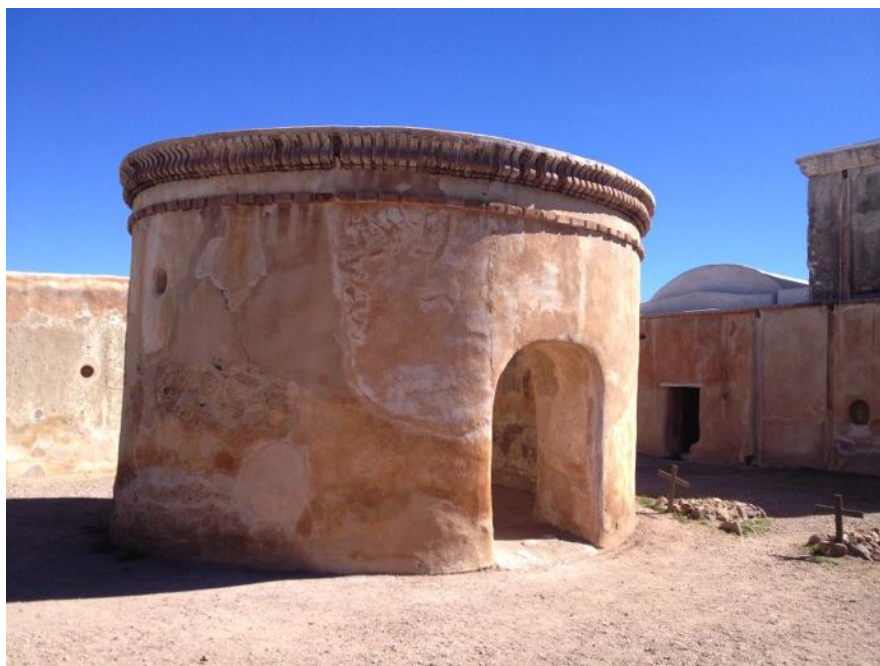
Figure 30: Mortuary chapel located in the southern center of the burial grounds with a west facing entrance and ornamental grave markings along the on the south tangent of the building, facing southeast (Alex Cardenas, February 2014).

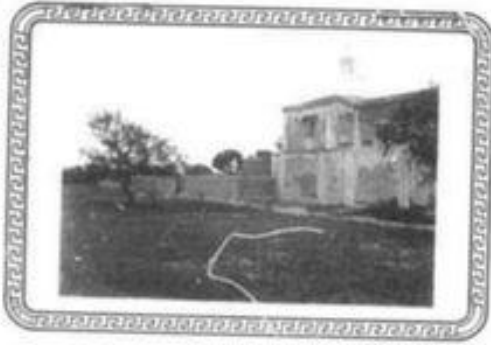
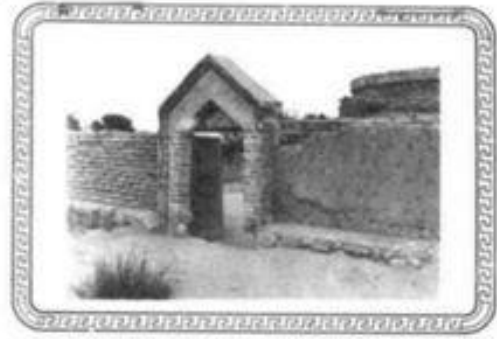
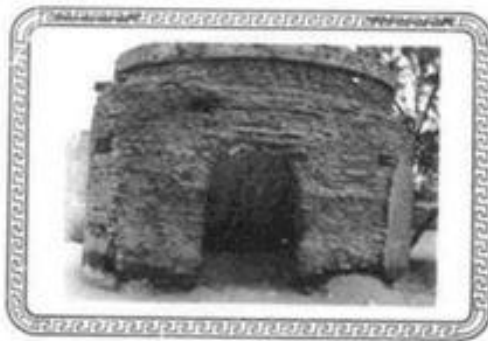
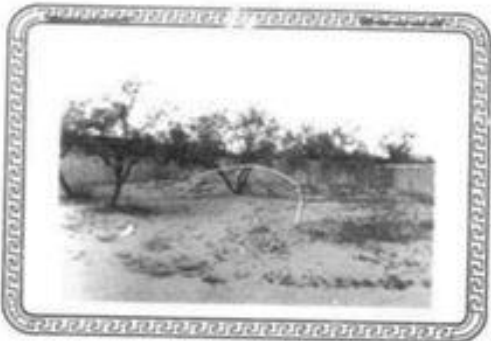
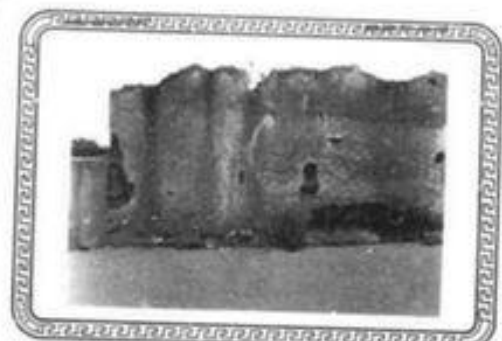
THE CEMETERY

1. From outside, looking N. E.

2. Gate; Restored. Mortuary Chapel shows over wall.

3. Mortuary Chapel.

Figure 31: Photos from the Six Year Program for the Tumacácori National Monument, showing the burial grounds and mortuary chapel (Photographer unknown, 1934, WACC).

The reconstruction of the burial grounds walls was a task completed in 1918, soon after Pinkley's appointment as the custodian of Tumacácori. The refinement of walkways to help navigate the site in 1936 included creating an opening in the south part of the eastern wall to allow easier access to the burial grounds.
