CAMP NACO
(Camp Newell)
(Fort Naco)
West Newell Street
Bisbee
Cochise County
Arizona

HALS AZ-27
HALS AZ-27

WRITTEN HISTORICAL AND DESCRIPTIVE DATA

HALS NO. AZ-27

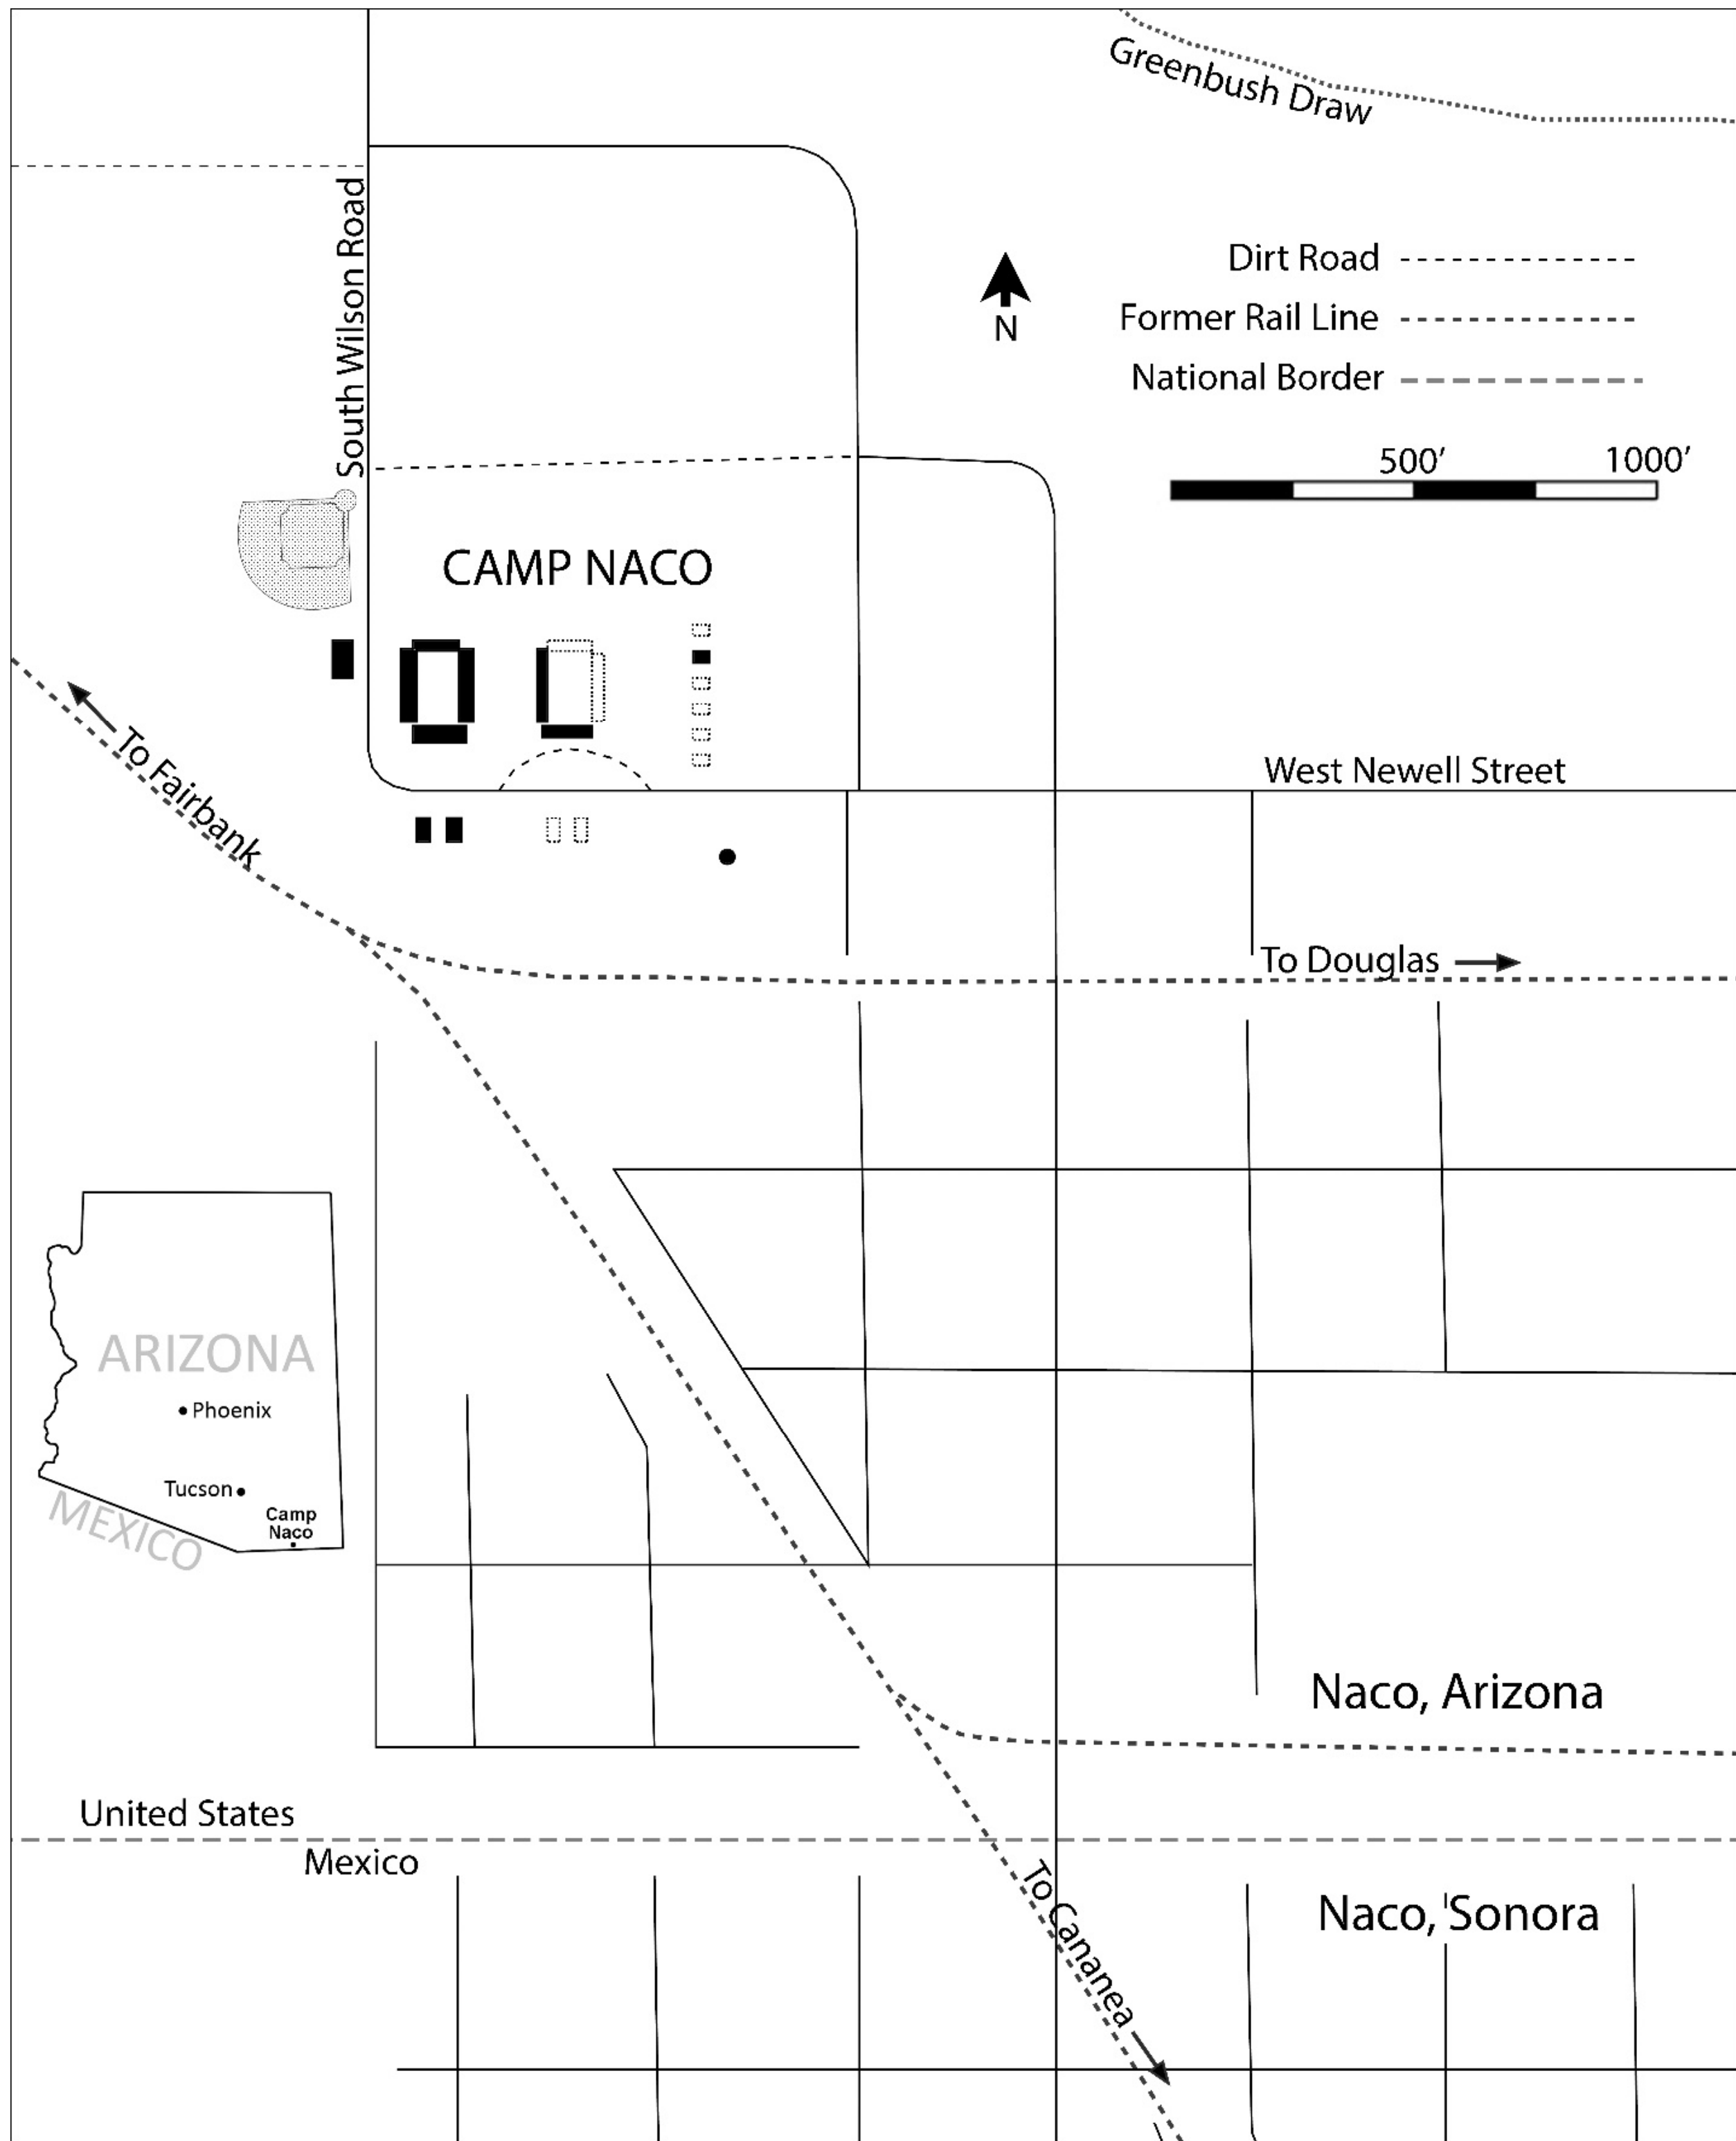
Figure 1: Measured map showing Camp Naco's location (Erickson, 2021).

Camp Naco is located in southeastern Arizona, just north of the border with Mexico and north and east of the junction of the former railroad lines that ran from Canonea, Sonora, to Benson, Arizona, and from Naco to Douglas, Arizona. Today it sits at the northeast corner of Wilson Road and Newell Street in Naco, Arizona. Neither road is historical. To the north is Greenbush Draw, which flows northwest to the San Pedro River. A level plain covered with desert vegetation runs north to the Mule Mountains. Three hundred yards to the south is the newly built border wall [Figure 1].

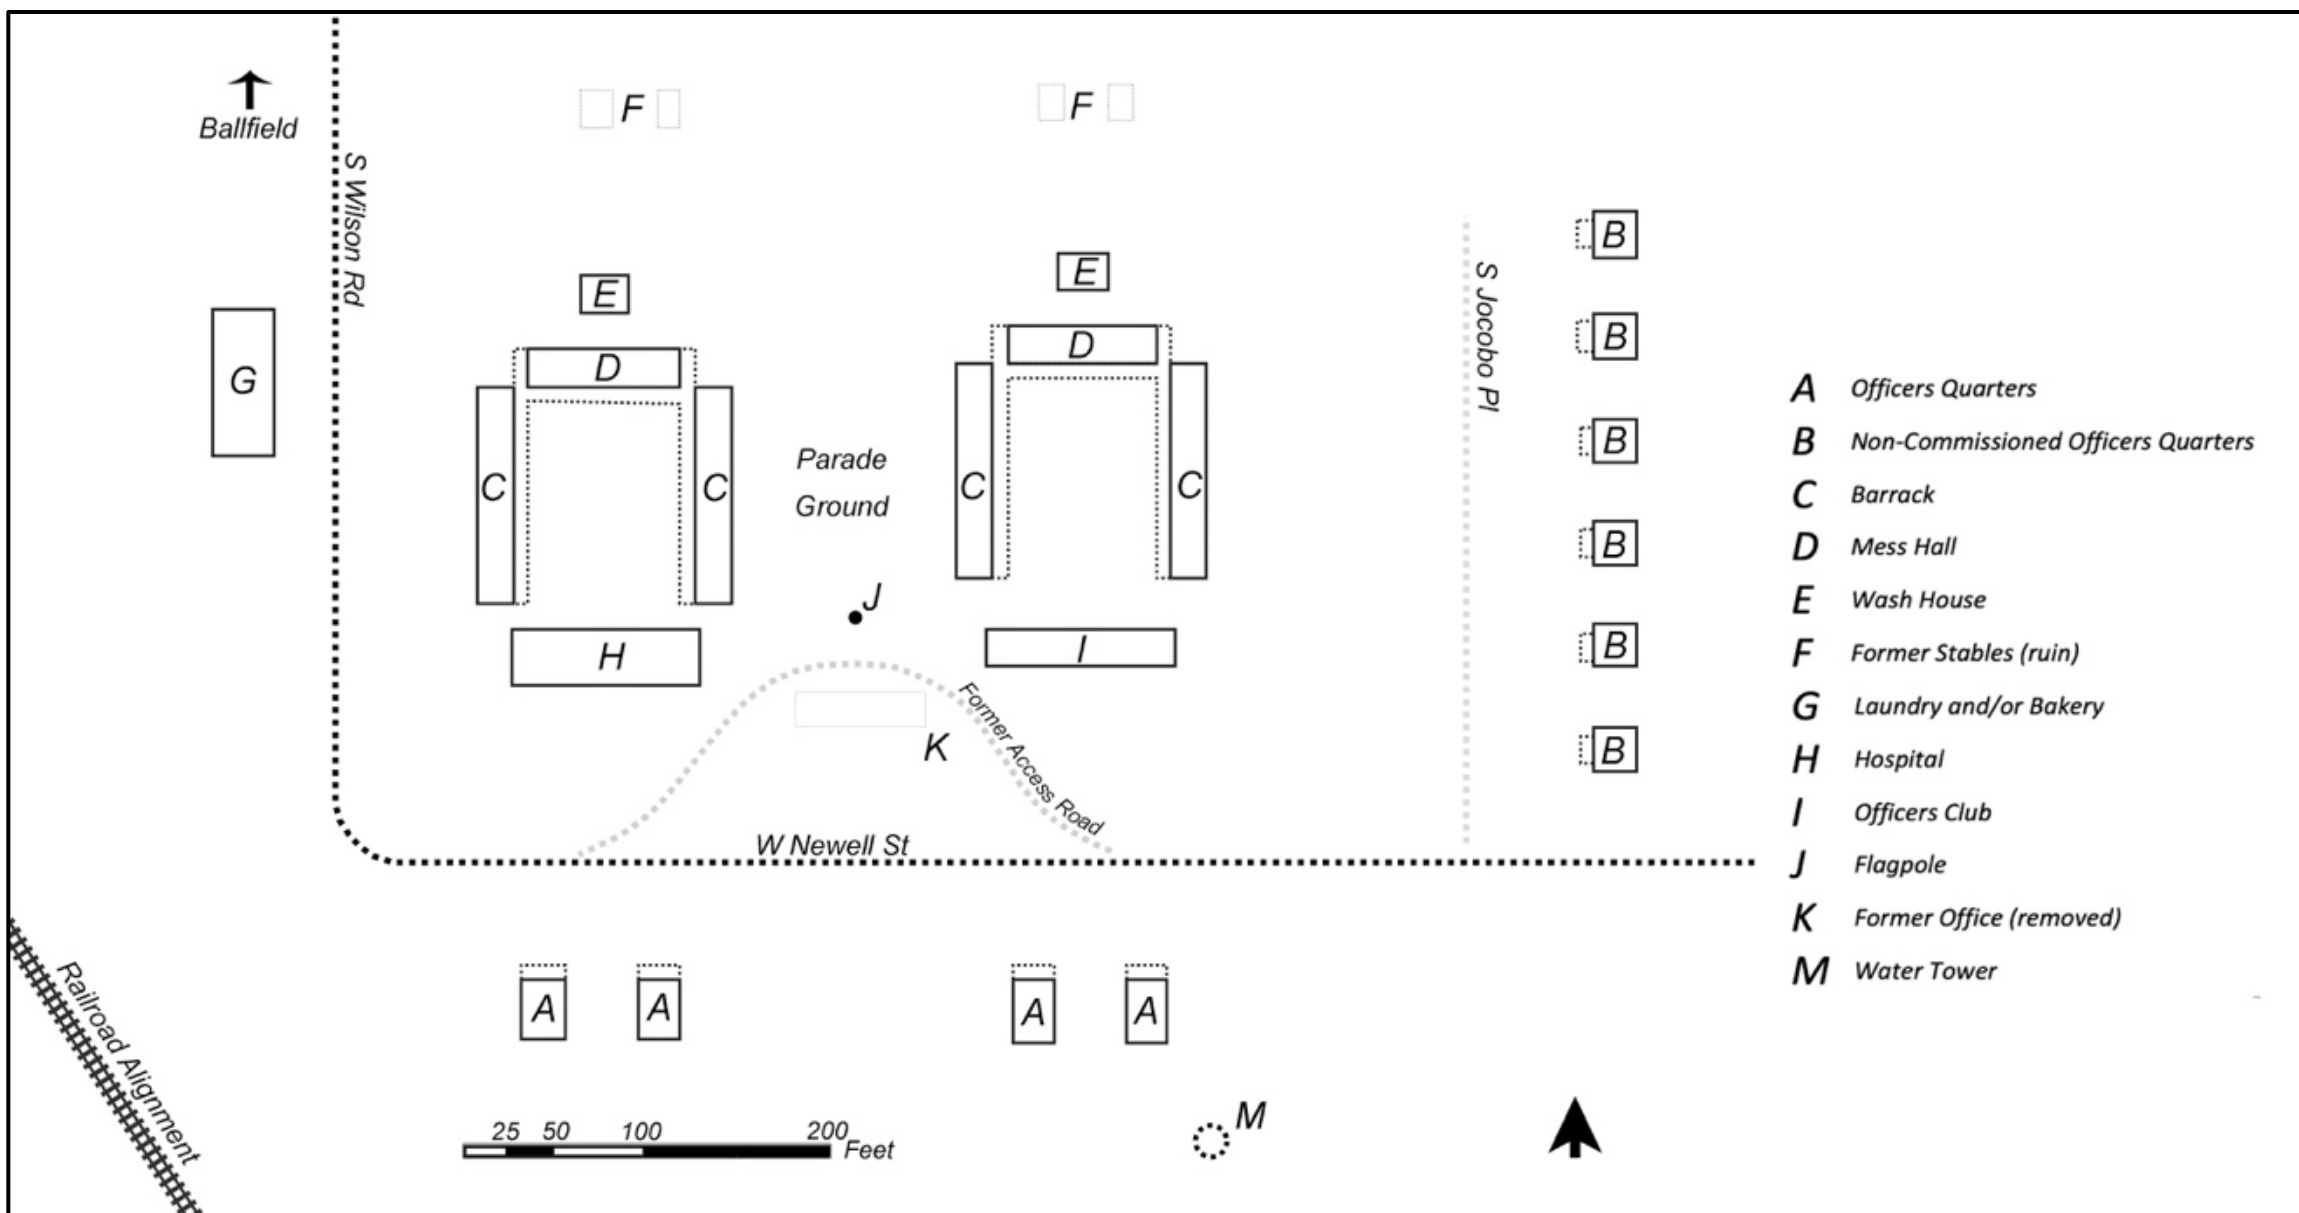
Figure 2: Measured map showing the layout of Camp Naco (Erickson, 2021).

Description: The camp is laid out in cardinal directions as is typical of military installations [Figure 2]. Four residences for commissioned officers – set in two paired units - lie at the southern end of the complex, facing inward towards the body of the camp to the north. Today they are separated from the rest of the property by Newell Street. The barracks, mess halls, hospital and officers' club form two quadrangles, each grouped around a common courtyard. Each barracks could house up to fifty soldiers. There is a small parade ground between the two quadrangles with a flagpole centered at the southern end. To the east of the quadrangles are six non-commissioned officers' residences, which face west towards the barracks.
